Riset Geologi dan  
Pertambangan (2026) Vol. 36,  
No. 1, 27–40  
DOI: 10.55981/  
risetgeotam.2026.1384

# Degradation risk assessment and hazard identification on geotourism site of Waluran District, Ciletuh Palabuhanratu UGGp

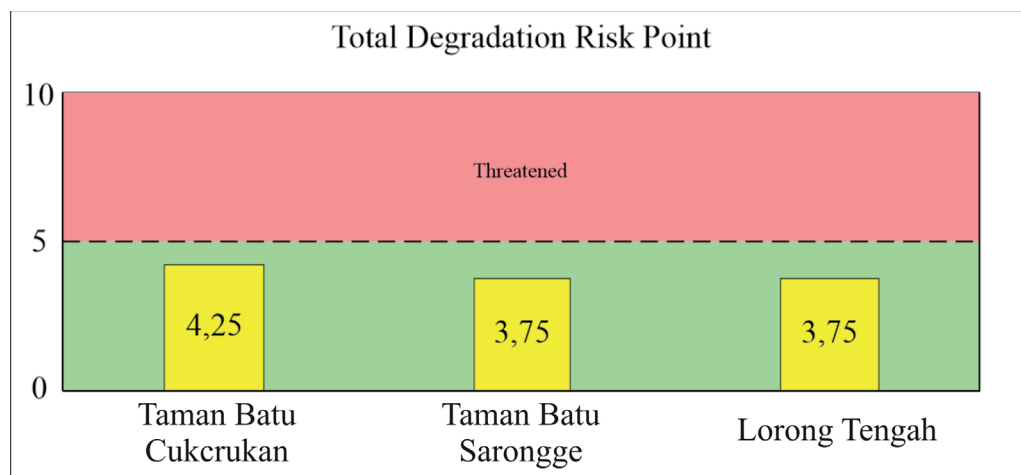
**Figure 3.** Bar chart representation of the total degradation risk point of 3 geosites observed in Waluran District.

The degradation risk assessment conducted using the Kubalíková et al. (2023) model shows that none of the three Waluran geosites are categorized as threatened, as none have a score exceeding 5 (Figure 3). Taman Batu Cukcrukun emerges with the highest total (4.25), largely due to its Problematic Areas score of 1.00, indicating proximity to human activity, hazard, and elevated susceptibility (Table 2). This aligns with broader observations in Ciletuh-Palabuhanratu UNESCO Global Geopark, where physical hazards such as rockfalls and slope instability have been identified as key risks to visitor safety and site integrity (Herlinawati et al., 2025). In addition, the landslide susceptibility map of West Java by PVMBG shows that all three geosites are located within a moderate-risk zone, where slope movements may occur along river valleys, escarpments, and road cuts, especially when slope stability is disturbed by intense rainfall and erosion. In comparison, Taman Batu Sarongge and Lorong Tengah both obtained a score of 3.75, with a Current Use factor of 0.50 (Table 2). This indicates the influence of human activities, primarily agricultural practices with limited formal development, which may pose potential challenges to the long-term sustainability of these sites. Although these activities are less intensive, they still mirror a wider pattern in global geoparks, where human use without management structures gradually erodes site quality (Selmi et al., 2022; de Lima et al., 2010).

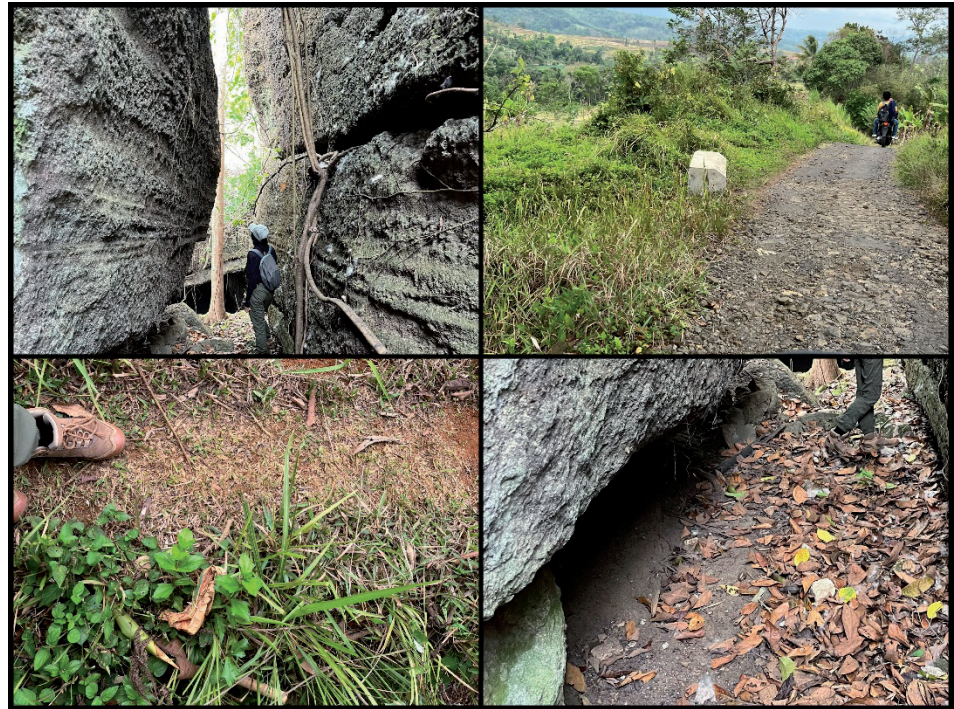
Taman Batu Cukcrukan, located in Waluran Village at coordinates 7°13'49.3" S and 106°36'24.9" E, is a striking area featuring rock outcrops forming a small rocky waterfall (Figure 4). Field observations identified five potential hazards in the vicinity, with risk assessment categorizing three as high (60%) and two as moderate (40%) (Table 3). The detailed analysis of these hazards, including their identification, risk evaluation, and recommended control measures, is provided in Table 3. High-risk categories are predominantly mobility-related, such as walking and driving on steep roads and narrow tracks, where slips and falls are likely and may cause severe injury. Moderate risks, including uneven roads and rockfalls, are more localized but remain significant, particularly during visitor activities involving driving and walking. These hazards arise from a combination of natural conditions (e.g., rockfall from weathered slopes) and human activities (e.g., navigating small tracks or walking on slippery roads), with visitors most vulnerable during movement across uneven terrain.

**Figure 4.** Geosite condition of Taman Batu Cukcrukan, highlighting potential hazards such as uneven roads, narrow paths, dry leaves covering trails, and weathered rocks.

The findings indicate that immediate interventions are necessary to mitigate accident potential and enhance site accessibility. Recommended measures follow the ISO 45001 hierarchy, including elimination (removing slippery leaves), engineering (paving roads, slope stabilization), and administrative actions (warning signage and routine maintenance). Implementing these controls not only minimizes accident likelihood but also supports long-term conservation by reducing human-induced pressures on fragile landforms.

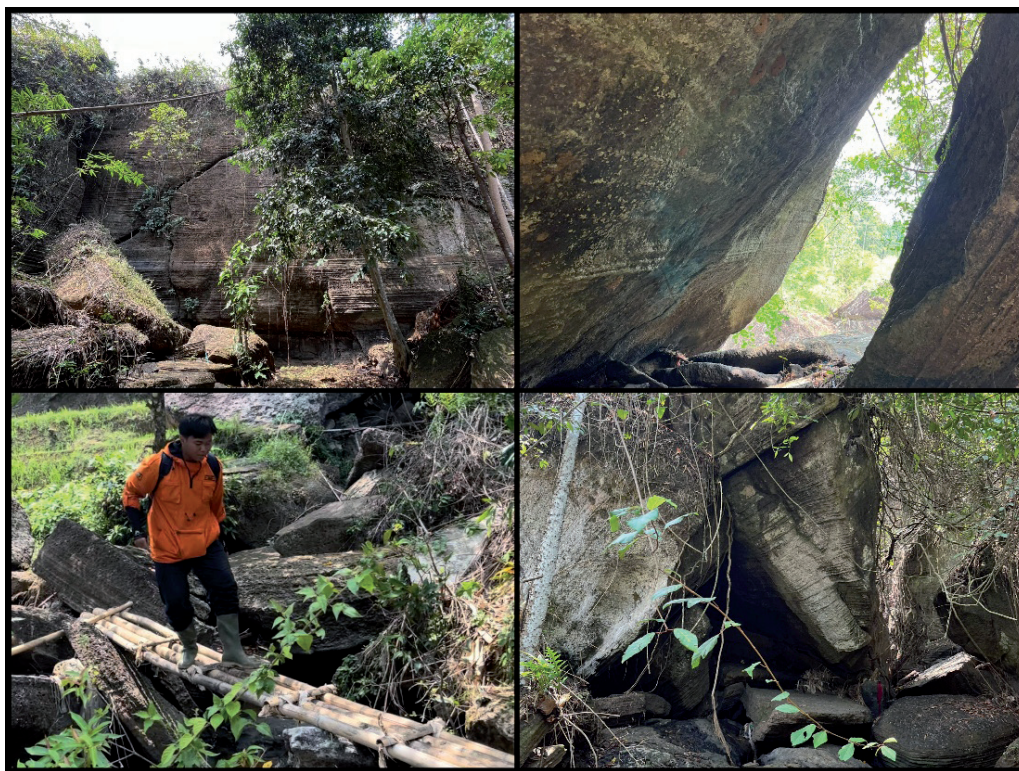
Taman Batu Sarongge, Goa Maung, and the Waluran Pillow Lava are geotourism sites located within the same complex area in Waluran Village, at coordinates  $7^{\circ}14'03.8''$  S and  $106^{\circ}36'40.1''$  E (Figure 5). Field observations identified three potential hazards in the vicinity, with risk assessment categorizing one as high (33,3%) and two as moderate (66,7%). The detailed analysis, including hazard identification, risk evaluation, and recommended control measures, is presented in Table 4. The high-risk category is mainly associated with walking activities on slippery rocks around the river, where the likelihood of slipping is considerable and may cause minor injury. Moderate risks include crossing a small wooden bridge without handrails and walking near areas with loose or fallen rocks, both of which present hazards ranging from falls with severe injuries to potential rock strikes that could be fatal in extreme cases. These risks stem from a combination of natural factors (e.g., unstable slopes and weathered rocks) and insufficient infrastructure (e.g., the absence of handrails on bridges). Visitors are particularly vulnerable during activities requiring balance and movement across unstable or slippery terrain.

**Figure 5.** Geosite condition of Taman Batu Sarongge, highlighting potential hazards such as a narrow wooden bridge without handrails, slippery moss-covered rocks, and weathered rocks

The findings emphasize the importance of immediate risk mitigation to ensure visitor safety while maintaining the site's natural integrity. Recommended interventions follow the ISO 45001 hierarchy, including engineering measures (improving the wooden bridge structure and adding handrails), administrative actions (installing clear warning signs to increase visitor awareness), and substitution strategies (rerouting paths to avoid areas prone to falling rocks). Implementing these measures can substantially reduce accident potential and enhance the overall safety of geotourism activities.
